REPAIR AND STRENGTHENING OF REINFORCED CONCRETE BEAM-COLUMN
JOINTS

HONORS THESIS

The Ohio State University

2010

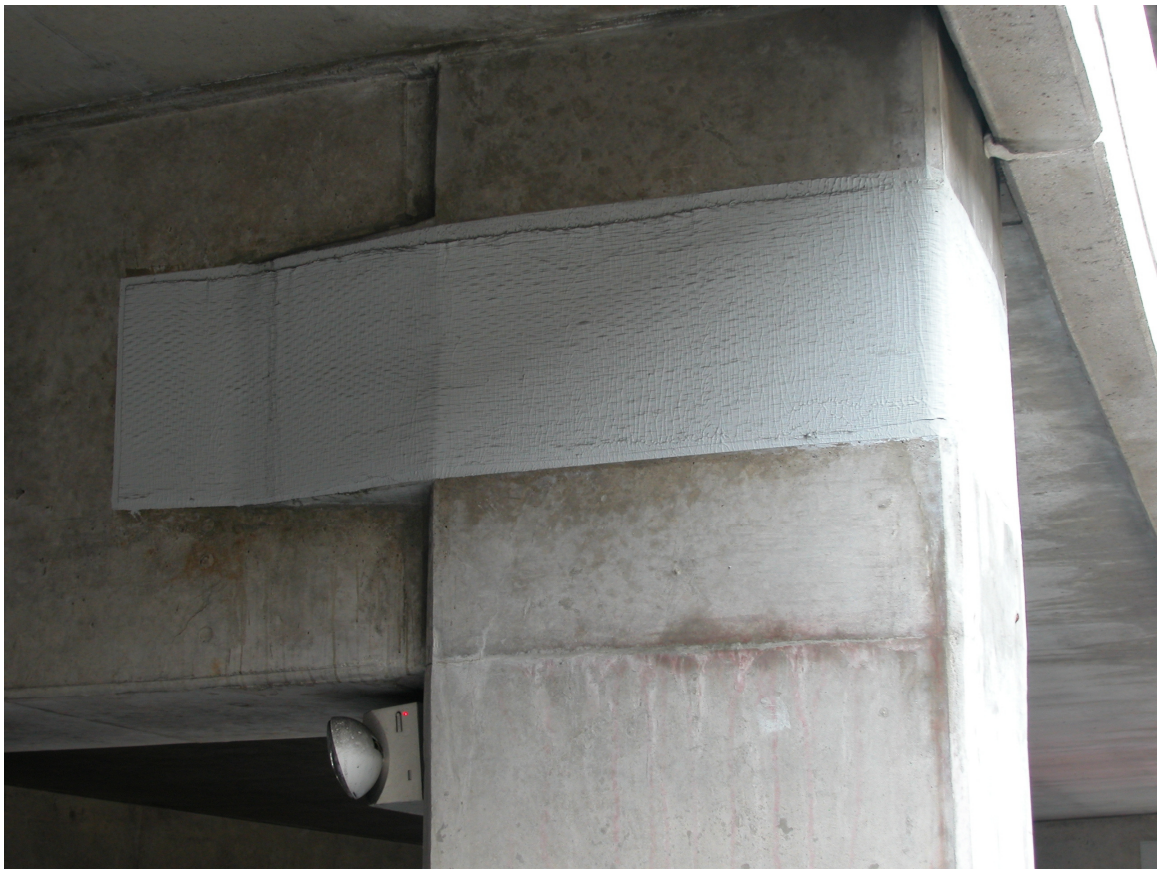
Figure 1.1-Example of FRP used in Tuttle Parking Garage on the campus of The Ohio State University, Columbus, Ohio

fiber reinforced polymers in areas on the beams and columns that is most critical for load resistance, testing the retrofitted concrete beam-column joints, and comparing original and retrofitted strengths to determine if the beam-column joints gained additional strength through retrofitting. The main objective is to determine if the proposed retrofitting method provides additional strength as compared to the strength of the original specimens. An example of FRP being used is shown in Figure 1.1.

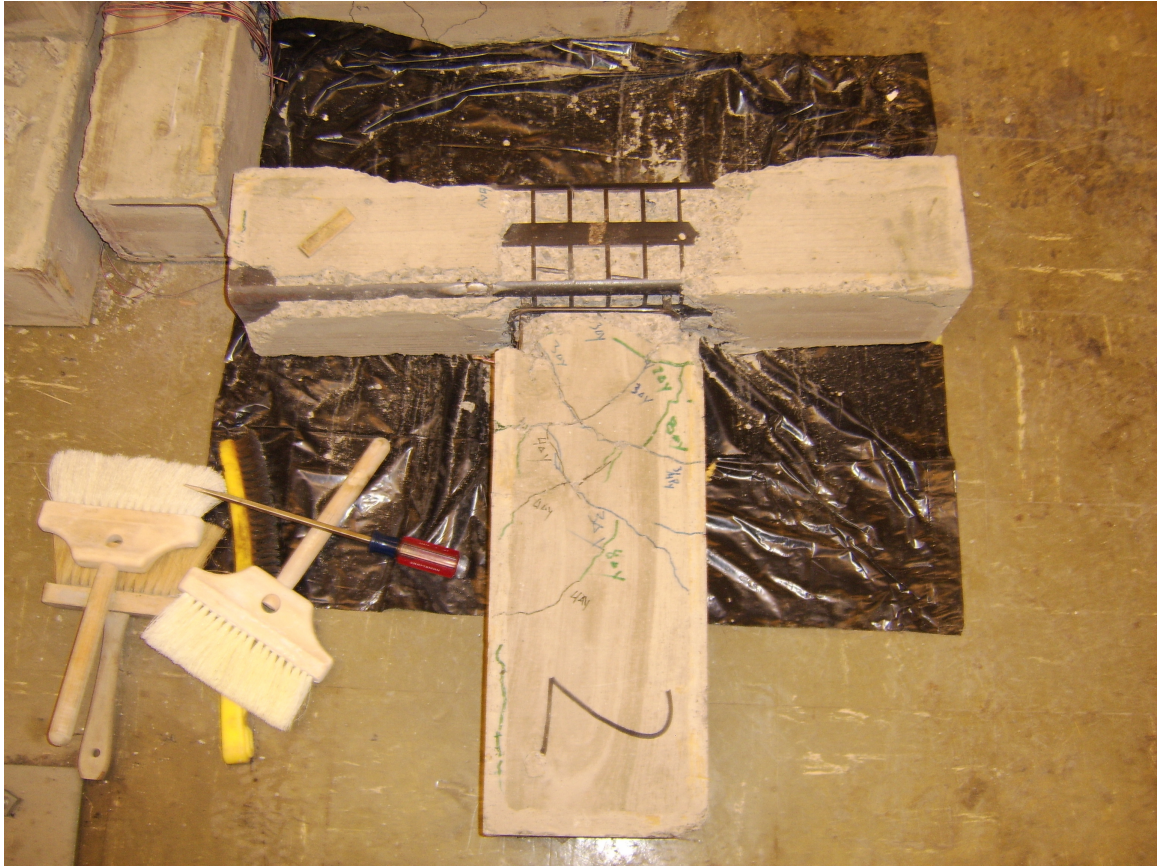
Figure 2.3-Fisher's Specimen 2 showing the typical damaged beam-column joint (Note: This specimen was not retrofitted; this is only to show a typical damaged specimen.)

This project began with Fisher's finished project. Fisher (2009) tested six beam-column joint specimens to failure. Three of these specimens' (Specimens 1, 3, and 5) columns were reinforced with standard longitudinal and traverse steel. The remainder specimens' columns were reinforced with a prefabricated cage system (PCS), a special reinforcement recently developed at The Ohio State University (Figure 2.3). Due to the different type of reinforcement, only specimens 1, 3, and 5 were considered in this research project since this is the traditional reinforced concrete system currently used.

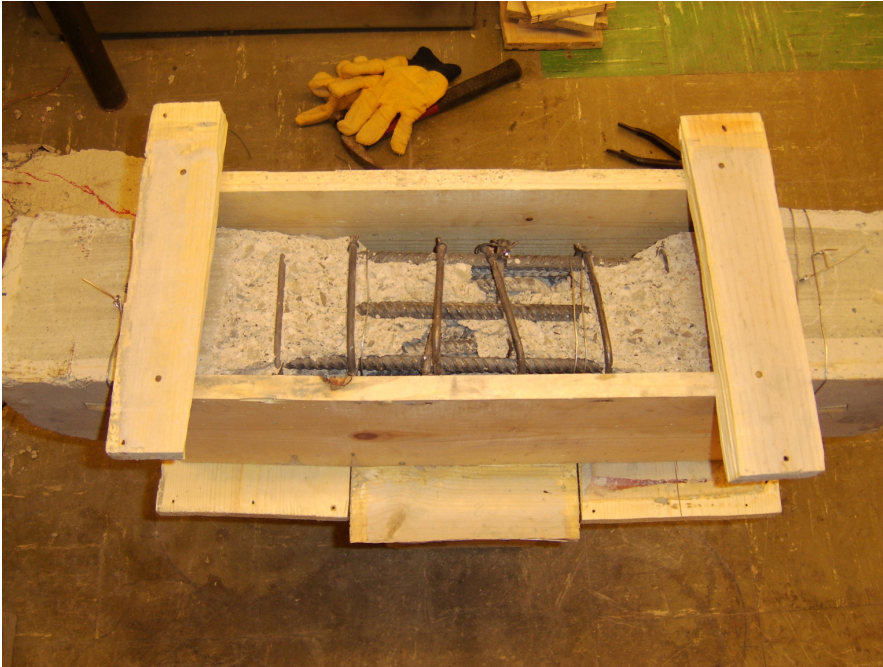
Figure 2.4-Specimen 5 forms from top. Back of column is shown.

Figure 2.5-Specimen 5 forms from side

The first step was to clean and prepare the three damaged specimens tested by Fisher (2009). Chisel and hammer were used to clean any loose pieces of concrete that may have been still attached to the specimens. Then, the next step was to take the old formwork used by Fisher to make new formwork around the highly damaged beam-column joints (Figures 2.4 and 2.5).

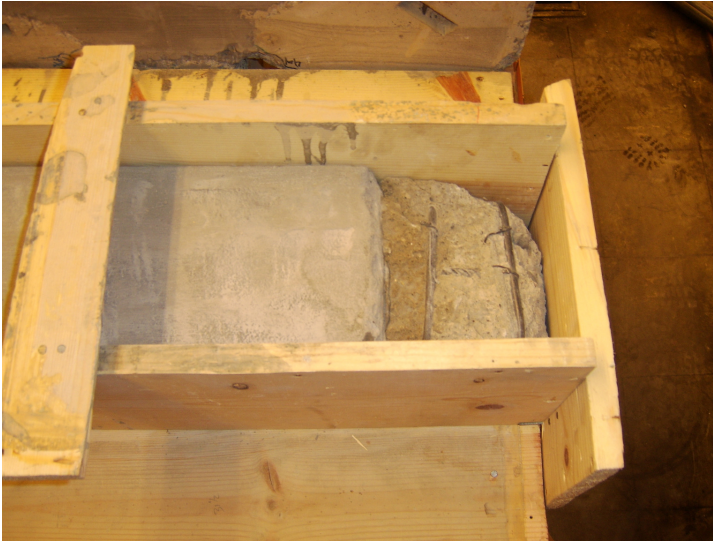
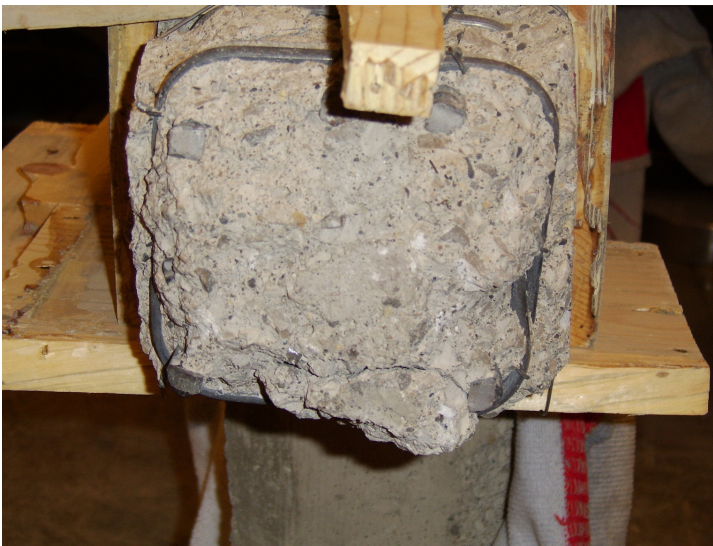
Figure 2.6-Specimen 3 extra formwork for damaged end (side view)

Figure 2.7-Specimen 3 damaged column end

However, Specimen 3 required additional formwork for one of its damaged column ends (Figure 2.6).

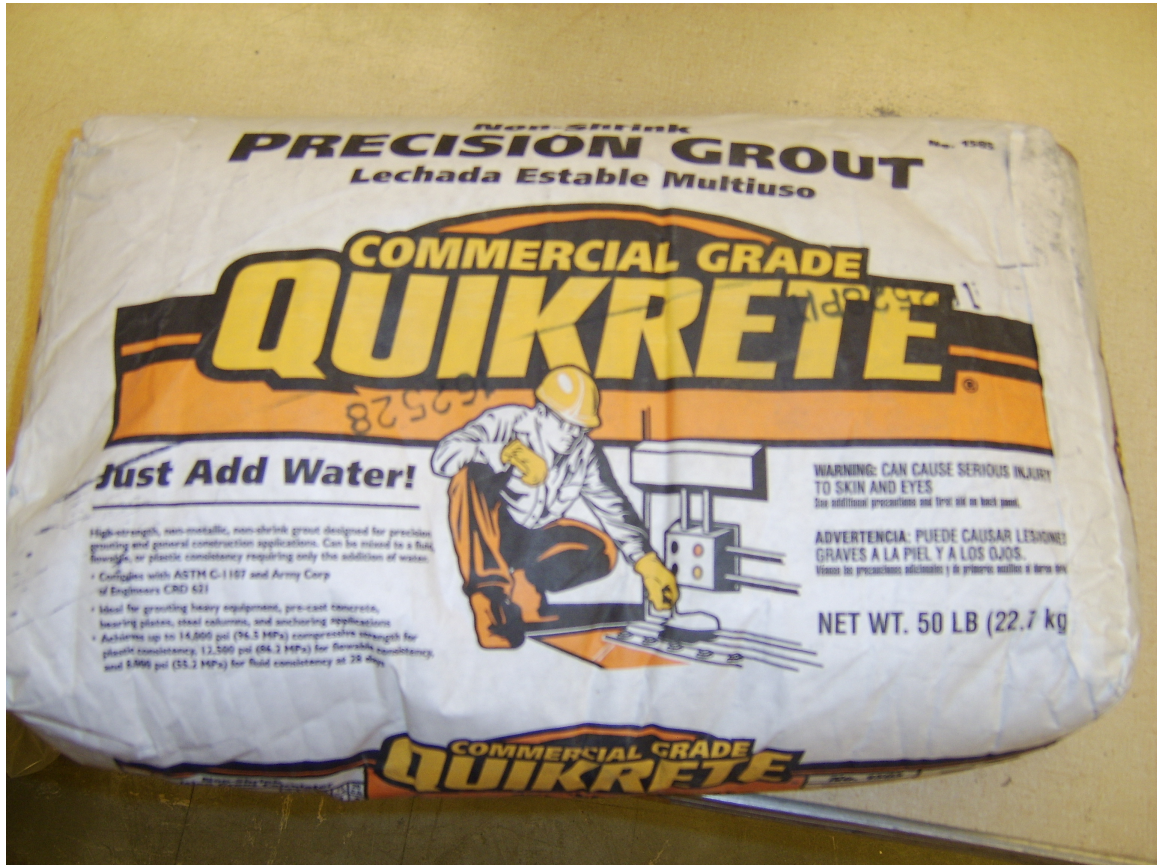
Figure 2.8-Bag of QUIKRETE® grout

Once the formwork was completed, a high-strength non-shrink grout was used to replace the missing concrete. This grout is made by QUIKRETE® (Figure 2.8). Attached in the Appendix is the specification data for this product.

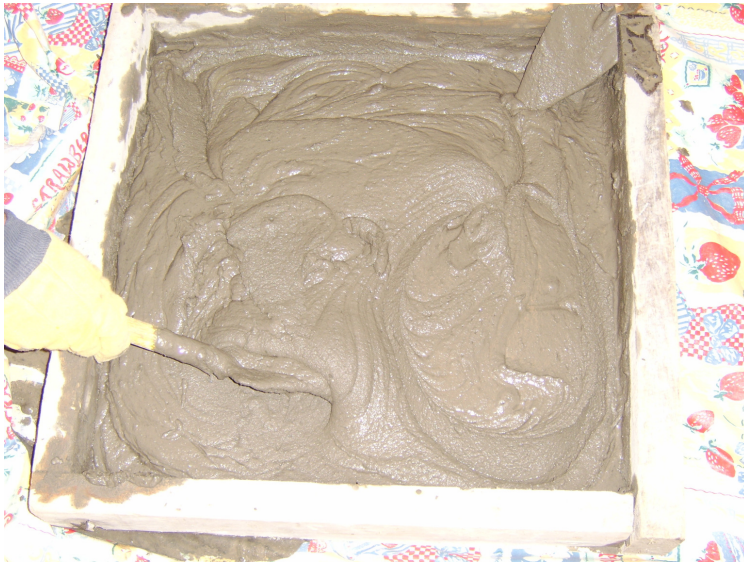
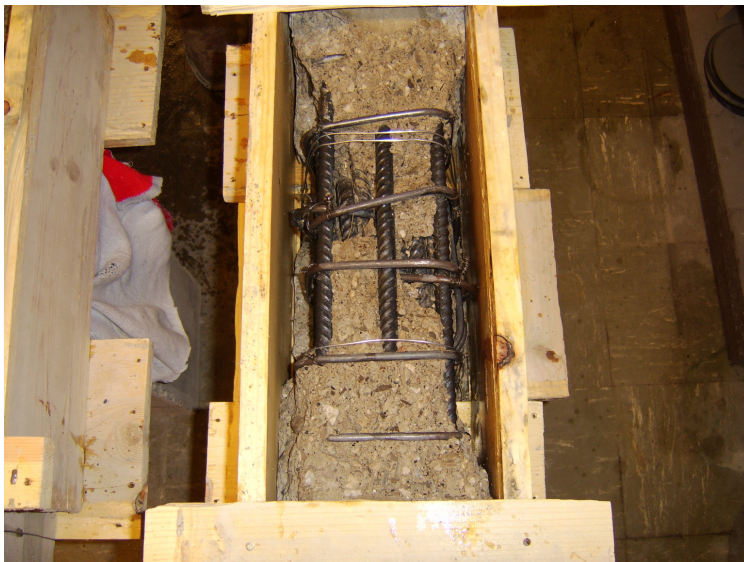
Figure 2.9-Grout mixed with water after 5 minutes

Figure 2.10-Water-coated original concrete to be grouted

Approximately one gallon of water was added to a 50-pound of grout and mixed in a mixing box for five minutes before being added to the beam-column joints (Figures 2.9). After mixing the water and grout for five minutes, the beam-columns' areas that were to be grouted were coated with water to help the grout's chemical reaction and bonding to the original concrete. The damaged areas of beams and columns were sprayed with water prior to application of grout (Figure 2.10)

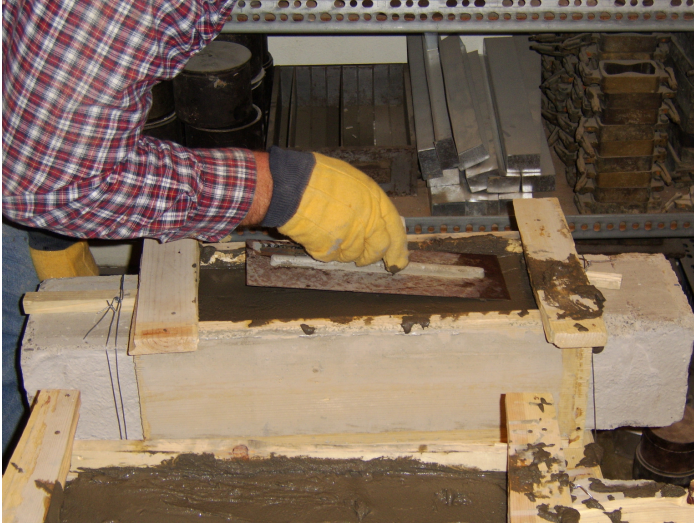
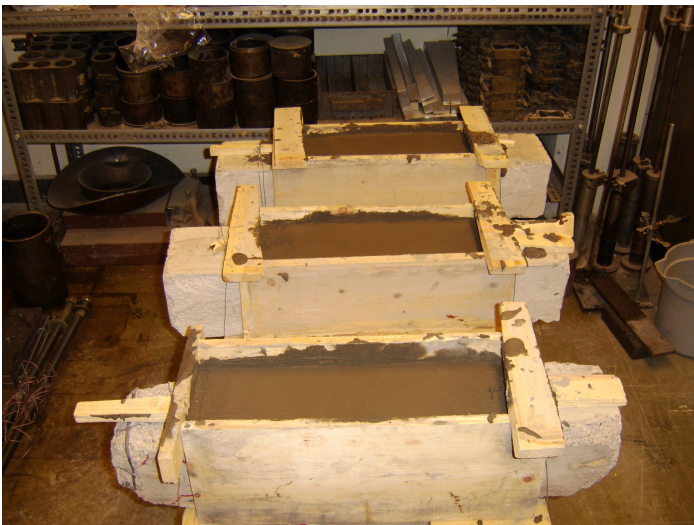
Figure 2.11-Smoothing the grout

Figure 2.12-The finished grouted joints

After coating the original concrete with water, the mixed grout was placed on the areas to be repaired. The grout was rodded to ensure that the grout penetrated and covered all of the exposed original concrete. Then, the grout was smoothed to form a smooth cover (Figures 2.11 and 2.12).

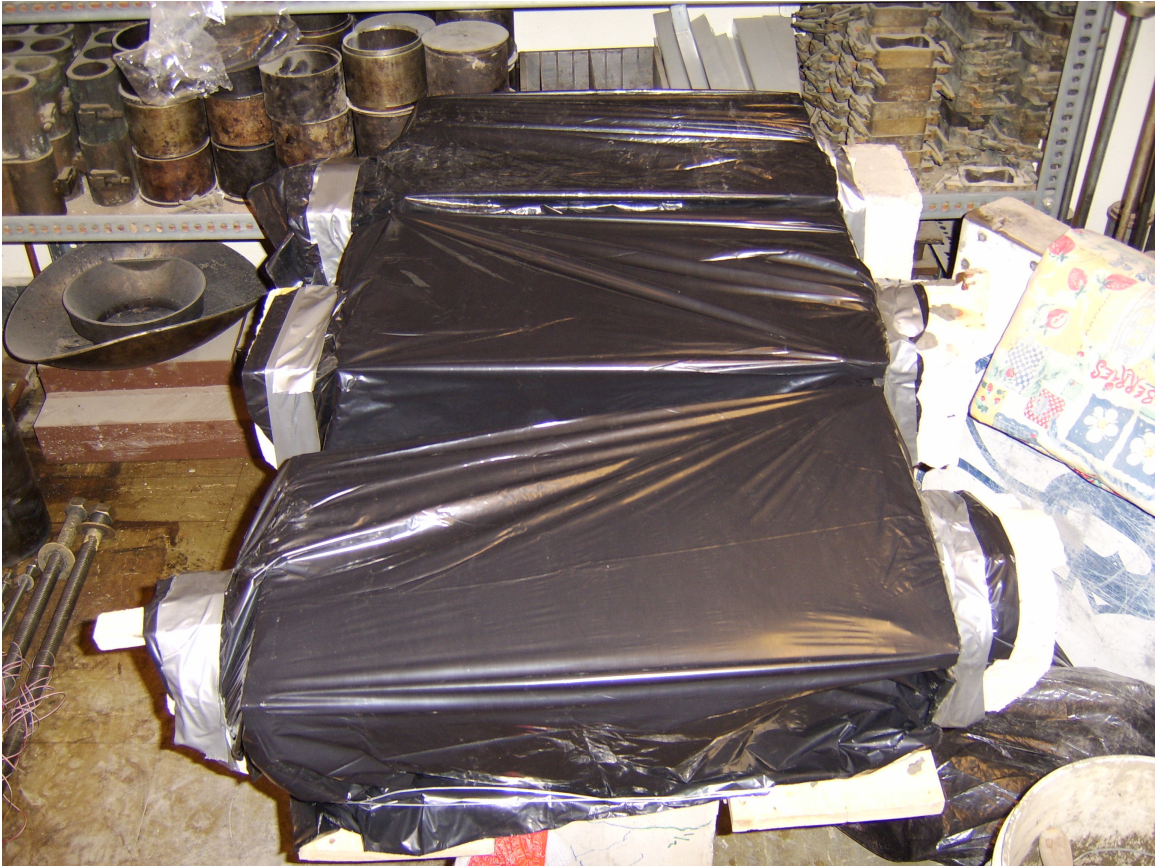
Figure 2.13-Curing procedure used

Once the joints were grouted, the grout was covered with plastic bags to allow the grout to cure properly (Figure 2.13). Also, for three days after grouting was completed, water

was sprinkled over the grout to allow proper curing. This occurred twice a day. The grout is projected to have a compressive strength of 14,000 psi after 28 days.

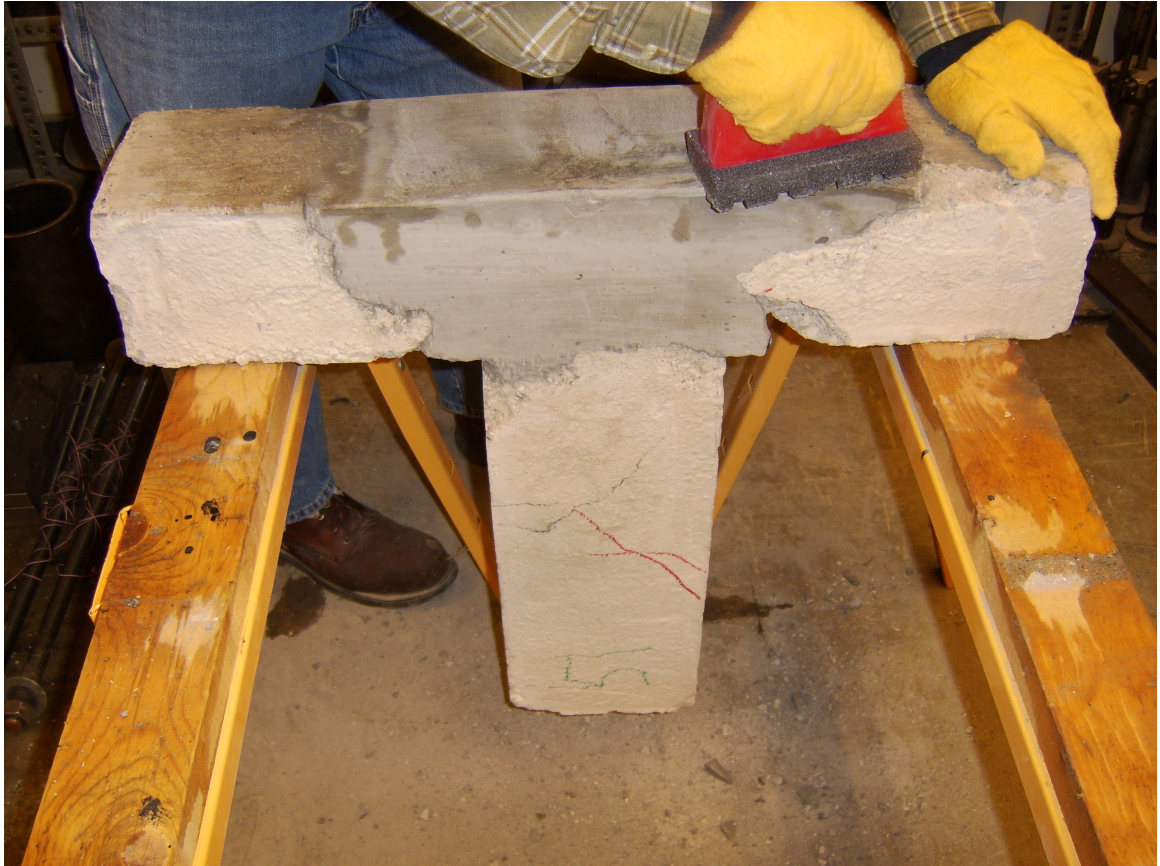
Figure 2.14-Using the rubbing stone to smooth rough grout

After the grout was allowed to cure for one week, the forms were removed. A rubbing stone was used to smooth the semi-cured grout to a level even with the existing concrete (Figure 2.14). Also, a hammer and chisel were used to break any loose grout that would not provide any structural strength.

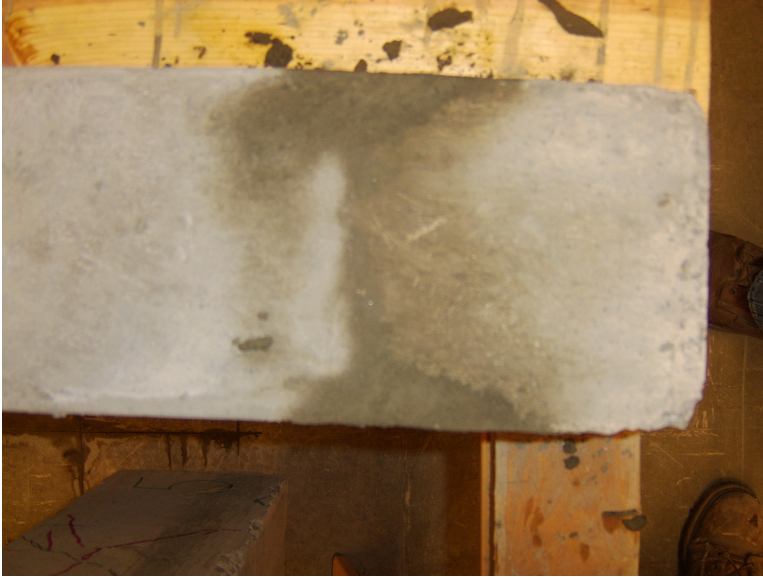
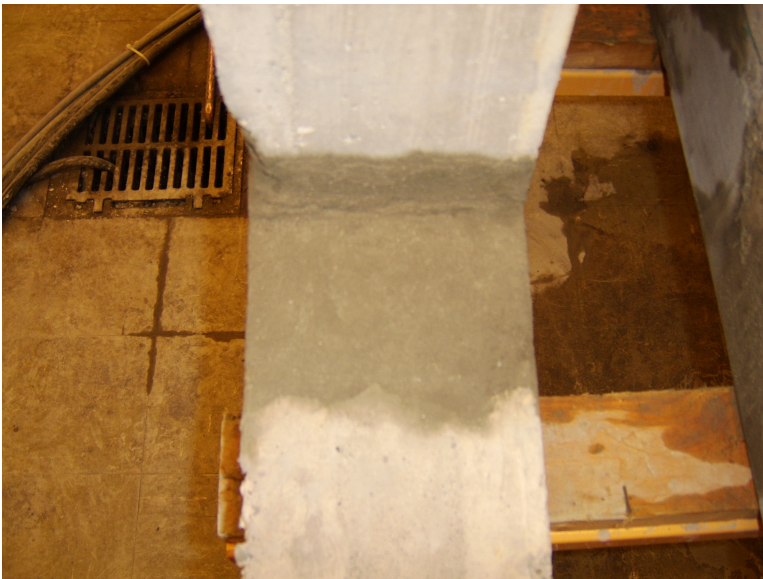
Figure 2.15-An example of a hand-grouted region

Figure 2.16-Another example of a hand-grouted region

Also, places that were still missing concrete and grout were puttied by hand using the non-shrink grout and without creating forms (Figures 2.15 and 2.16). Again, the specimens were covered with plastic to allow for curing. Also, they were watered again two times a day for three days.

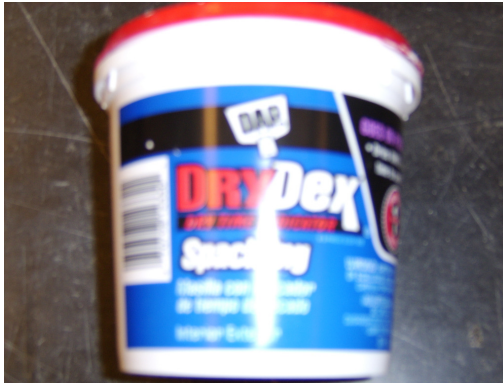
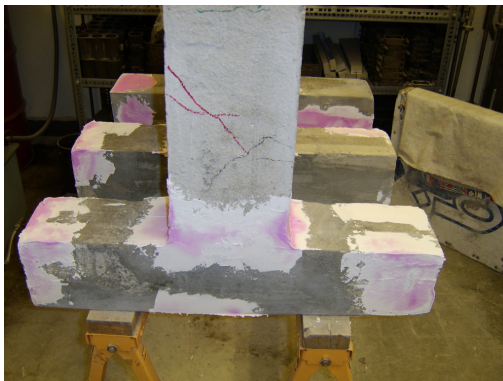
Figure 2.17-Spackling used for smoothing rough edges

Figure 2.18-Specimens after spackling complete

the rough grouted edges. Thus, the forces within the FRP would be distributed evenly over more area instead of jagged edges (less area for the forces to act) creating stress concentration within the FRP wrap. Less stress will allow the FRP to withstand more force before breaking. Any spackling found at a local hardware store could be used (Figure 2.17).

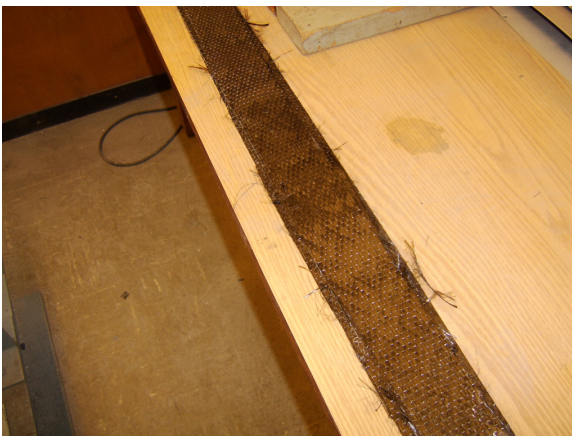
Figure 2.20-FRP cut into pieces in preparation of wrapping

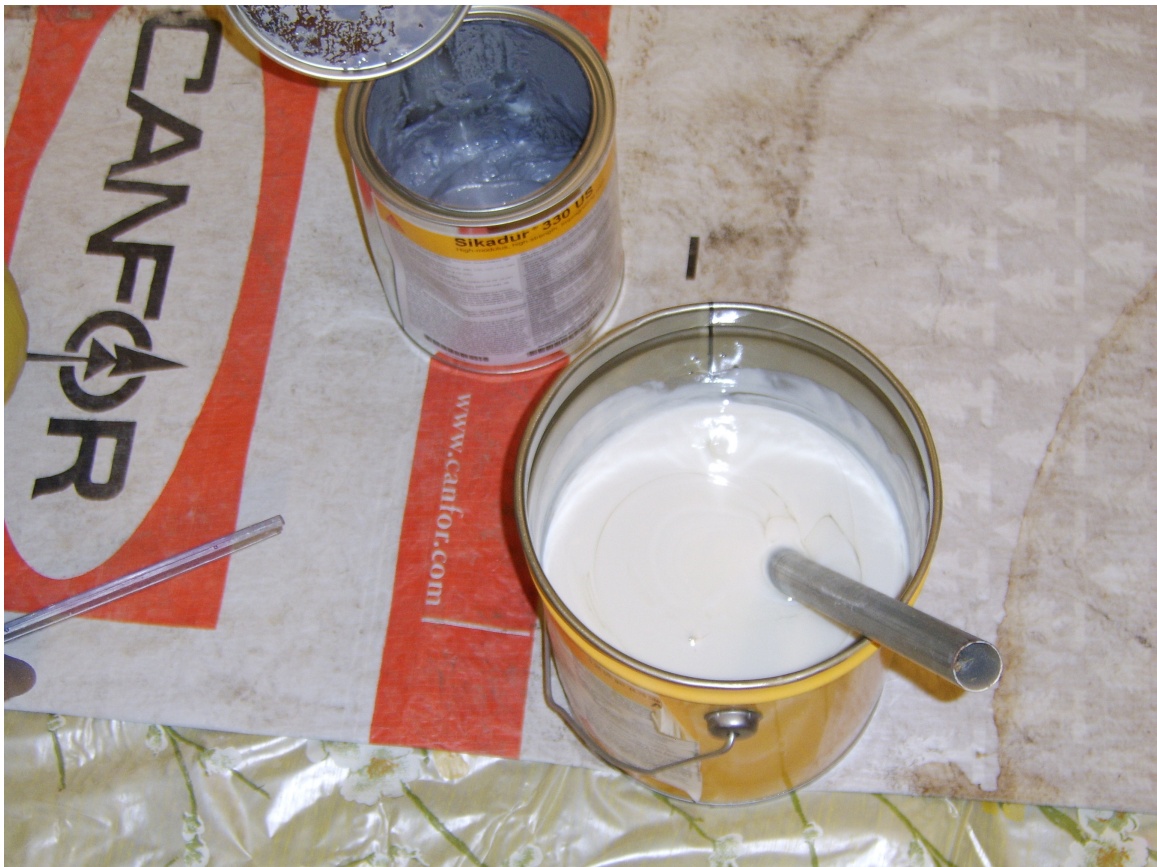
Sikadur® 330 US Epoxy was used to glue the FRP to the surface of the concrete specimens. Sikadur® 330 US Epoxy comes in two parts, Part A and Part B. The epoxy is created once these two parts are combined and mixed (Figure 2.21). The epoxy is applied to the areas of concrete to be wrapped with FRP. Then, the FRP is wrapped and smoothed around the concrete, and another layer of epoxy is applied to the wrap. This causes the wrap to harden as the epoxy dries. This method is called the “Dry Lay-Up Method.” Attached in the Appendix is the product data sheet for the epoxy.

Figure 2.21- Sikadur® 330 US Epoxy-Parts A and B before mixing

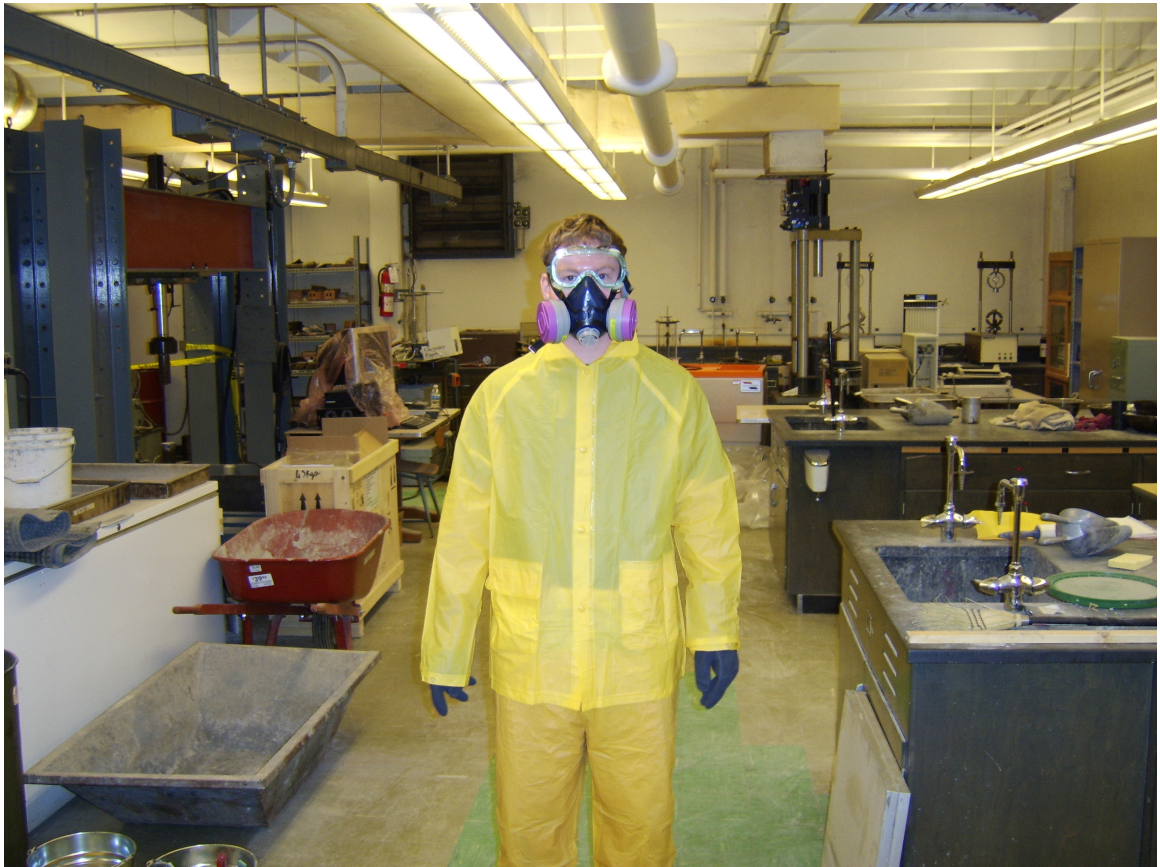
Since Sikadur® 330 US Epoxy is considered a hazardous material, special safety precautions had to be taken to avoid harm. NIOSH respirators, special gloves, goggles, and a plastic suit had to be worn to keep the epoxy from touching skin (Figure 2.22).

Figure 2.22-Protective equipment

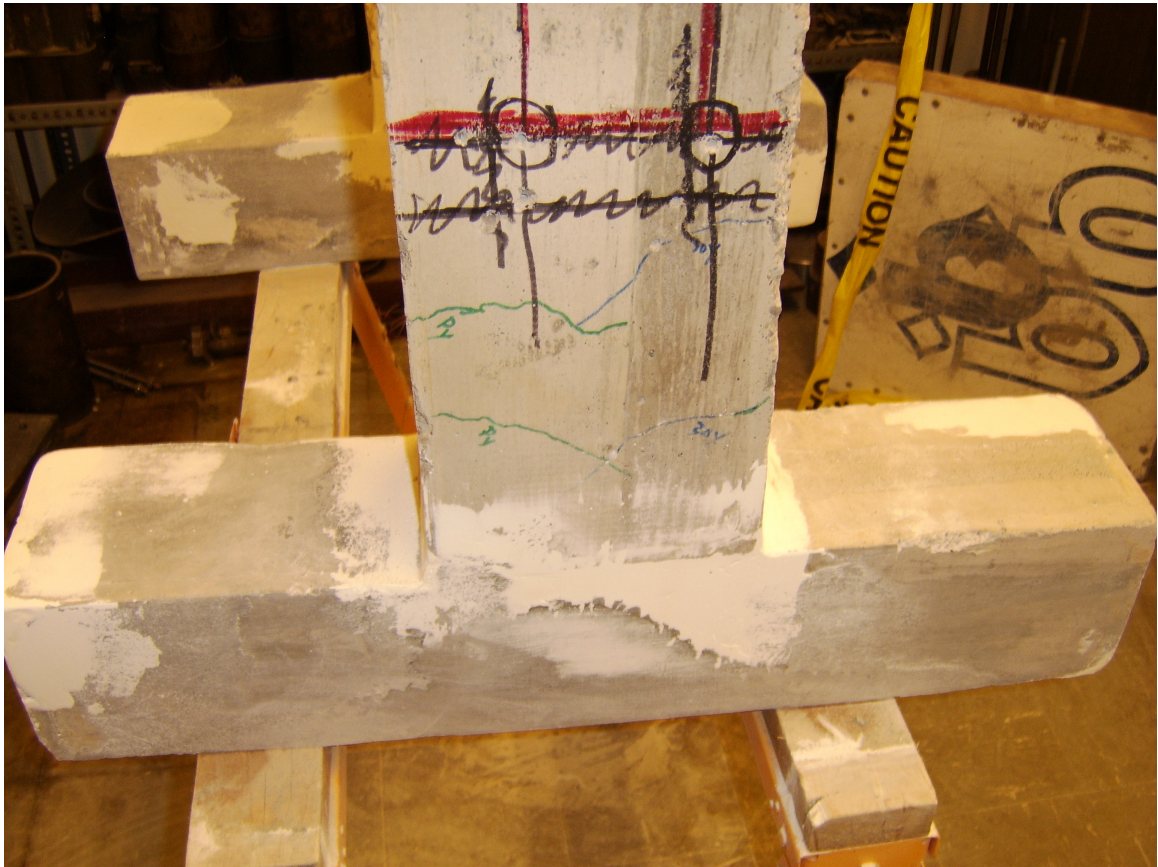
Figure 2.23-Hole locations for two Tapcons® screws

Tapcons® are self-tapping screws. The screws were used to help anchor and hold the FRP in place along the sides of the beams thus avoiding slippage. Holes for the screws were drilled approximately 12 inches from the face of the column and 2 to 3 inches from both edges of the beam. Variations in the locations of the holes occurred due to avoiding longitudinal and traverse steel (Figure 2.23). The retrofitted specimens prior to testing are shown in Figures 2.24 and 2.25.

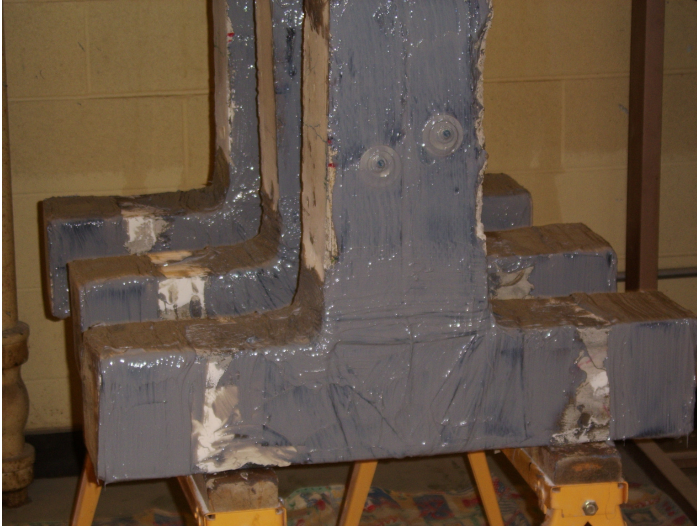
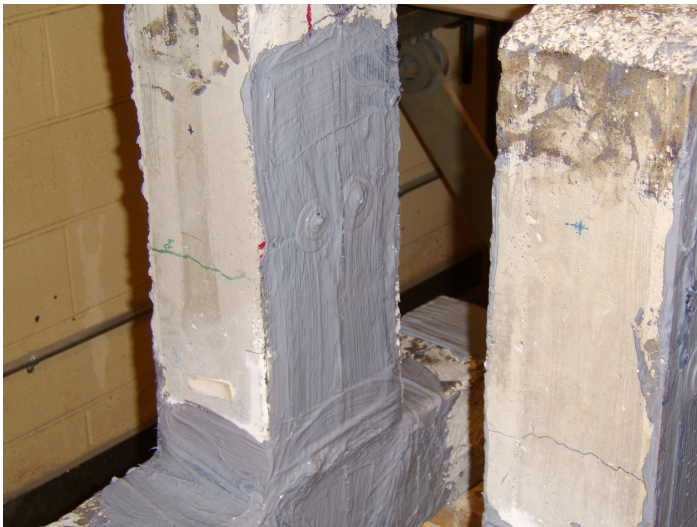
Figure 2.24-Finished retrofitted specimens

Figure 2.25-Second picture of finished retrofitted specimens

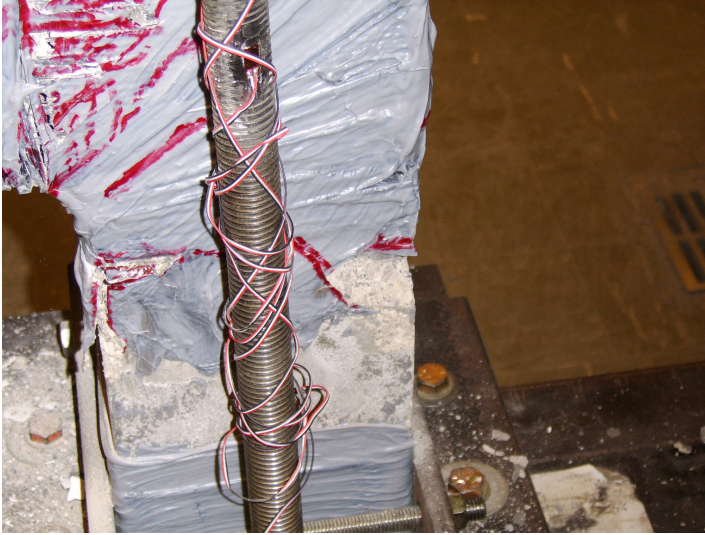
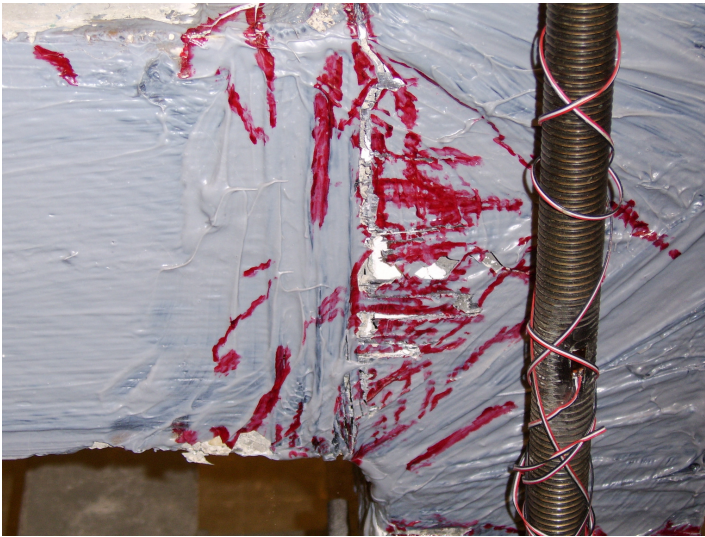
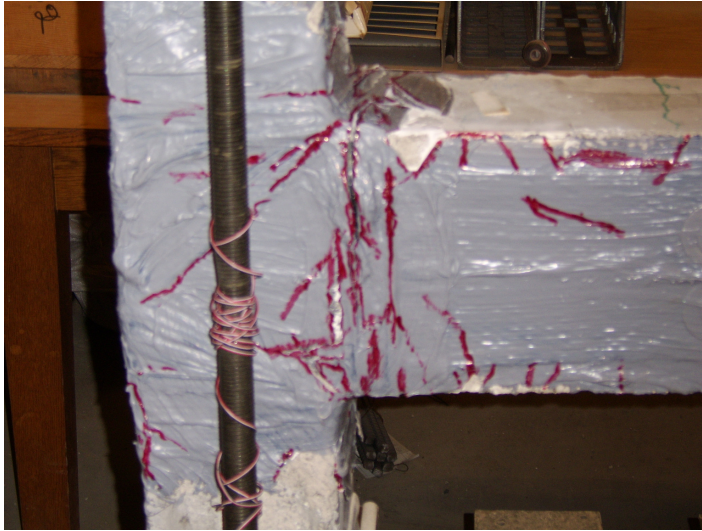
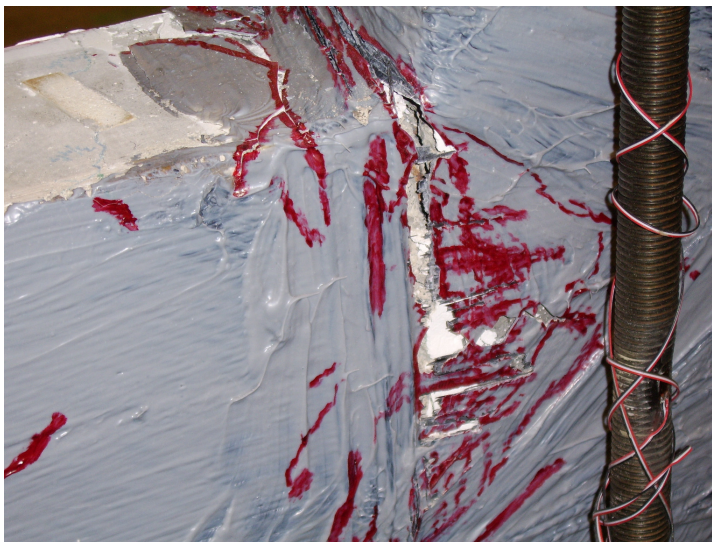
Figure 4.1-Specimen 1 failure

Figure 4.2-Specimen 1 failure

Figure 4.3-Specimen 1 failure

Figure 4.4-Specimen 1 failure

Specimen 1 eventually failed in flexure. At failure, the longitudinal FRP along the side of the beam tore apart near the joint of the specimen (Figures 4.1 through 4.4). The ends of the column remained in tact. The FRP did a very good job of keeping the column ends from chipping and breaking until the very end of testing. The failure of Specimen 1 can be compared to the original failure after Fisher's testing (Figures 4.5 and 4.6). The recorded load versus displacement relations are shown in Figures 4.7 through 4.17 for each load cycle defined in Table 3.1.

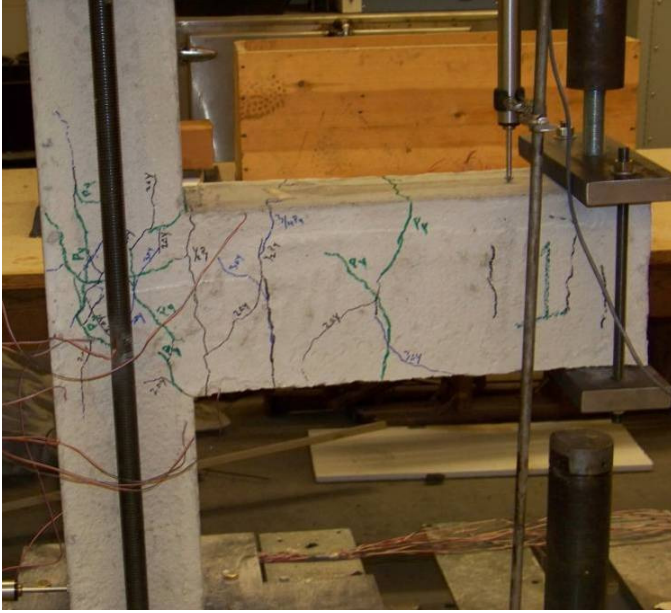
Figure 4.5-Specimen 1 after the $4\Delta_y$ load cycle (Fisher 2009)

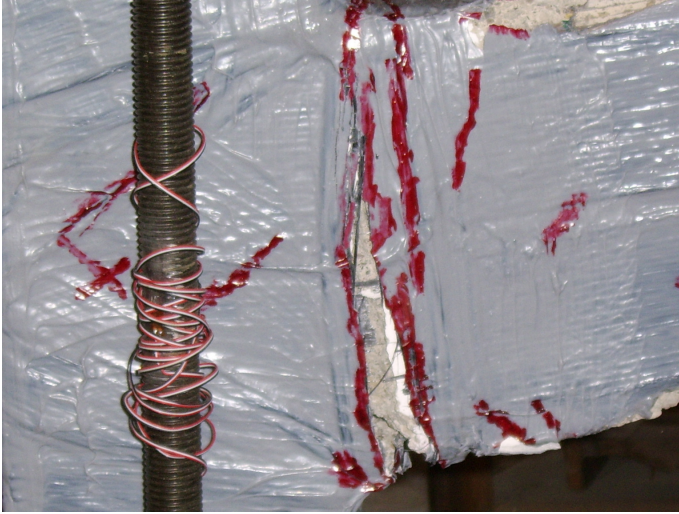
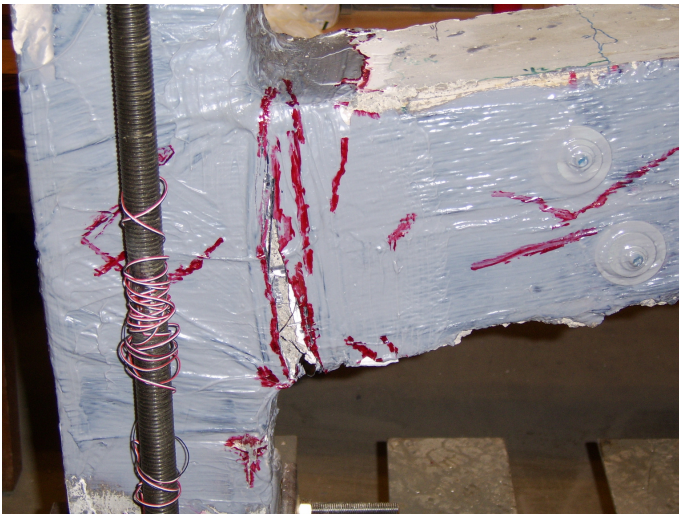
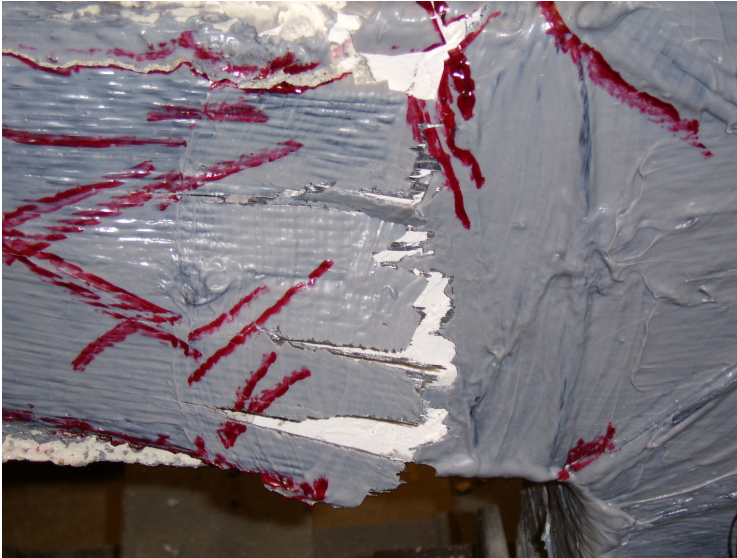
Figure 4.18-Specimen 3 failure

Figure 4.19-Specimen 3 failure

Figure 4.20-Specimen 3 failure

Figure 4.21-Specimen 3 failure

Specimen 3 failed in the middle of the Py cycle of Fisher's (2009) loading schedule and failed in flexure. The longitudinal FRP along the side of the beam tore apart near the joint of the specimen (Figures 4.18-4.21). The ends of the column remained in tact. The FRP did a very good job of keeping the column ends from chipping and breaking. Specimen 3's damage can be compared to the original damage after Fisher's testing (Figures 4.22 and 4.23). Refer to Figures 4.24 through 4.28 for load versus displacement graphs.

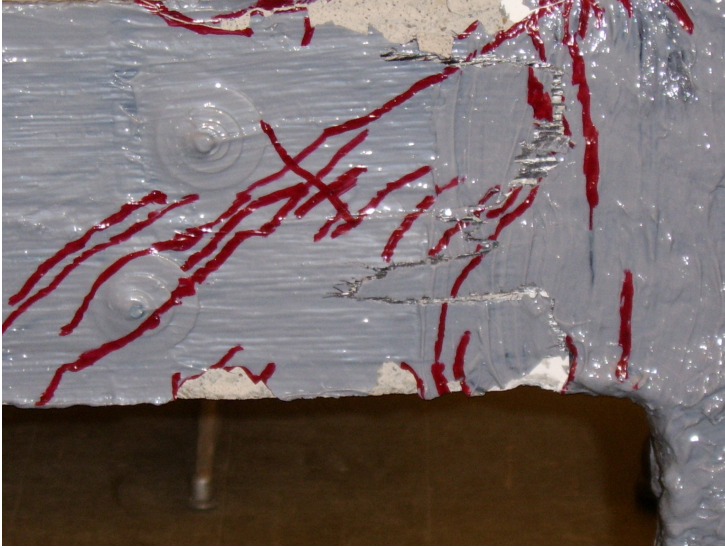
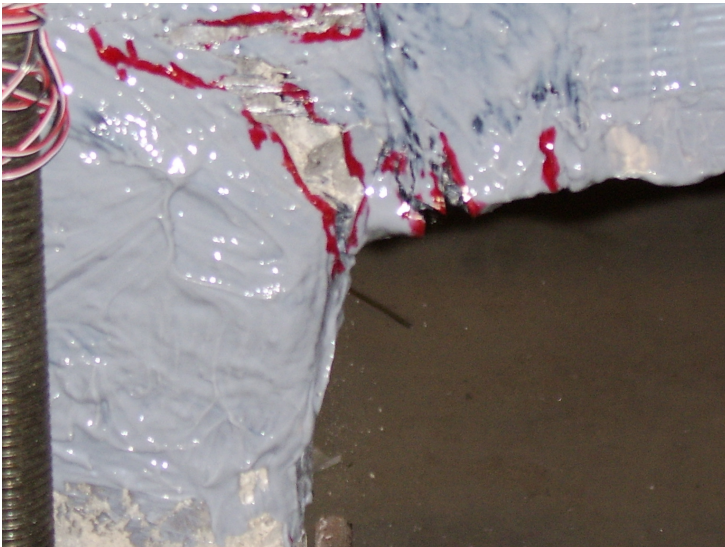
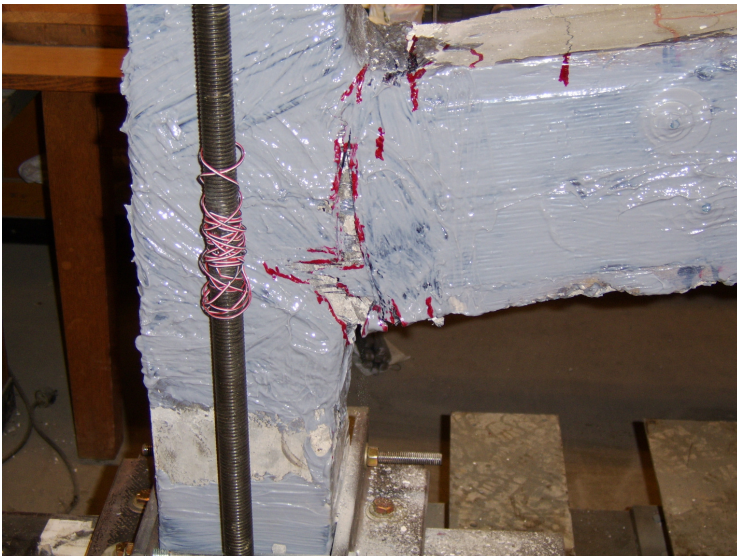
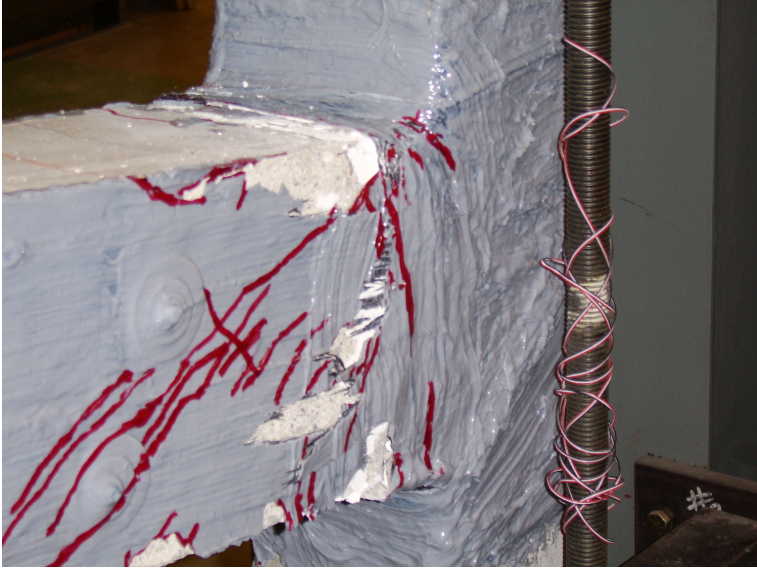
Figure 4.29-Specimen 5 failure

Figure 4.30-Specimen 5 failure

Figure 4.31-Specimen 5 failure

Figure 4.32-Specimen 5 failure

Figure 4.33-Specimen 5 failure

Specimen 5 failed in the middle of the 3/4 Py cycle of Fisher's (2009) loading schedule and failed in flexure. The longitudinal FRP along the side of the beam tore apart near the joint of the specimen (Figures 4.29 through 4.33). The ends of the column remained in tact. The FRP did a very good job of keeping the column ends from chipping and breaking. Specimen 5's damage can be compared to the original damage after Fisher's testing (Figures 4.34 and 4.35). Refer to Figures 4.36 through 4.39 for load versus displacement graphs.

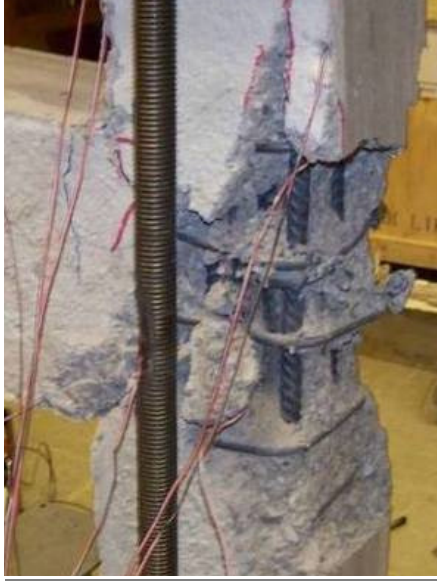
Figure 4.35-Another picture of Specimen 5 failure after P_y cycle
